Unburied Treasure Along the South Fork of the Stilly

Located about halfway between Red Bridge and the town of Silverton, a unique artifact is gradually being uncovered by the forces of nature along a rocky "beach" of the South Fork of the Stillaguamish River.

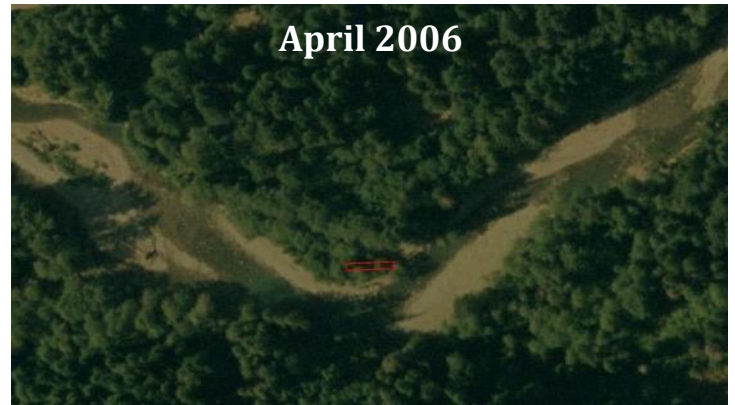
A Google Earth image dating back to July of 2003 shows that the entire structure was not only covered by various sizes of rock, but was also under the canopy of large trees (note the images on

page 3 taken April 2, 2019). In June of 2003, just a month before the satellite image was taken, the last group of school students to experience Camp Silverton before it was closed by the Everett School District were enjoying their outdoor environmental education classes. This part of the river at camp was always off limits. The April 2006 image shows about the same location where the wooden ruins was buried on the little seasonal island where the gold panning classes were taught. No Glacier boys would have seen the wooden ruins at that time even if they were standing right on top of it!

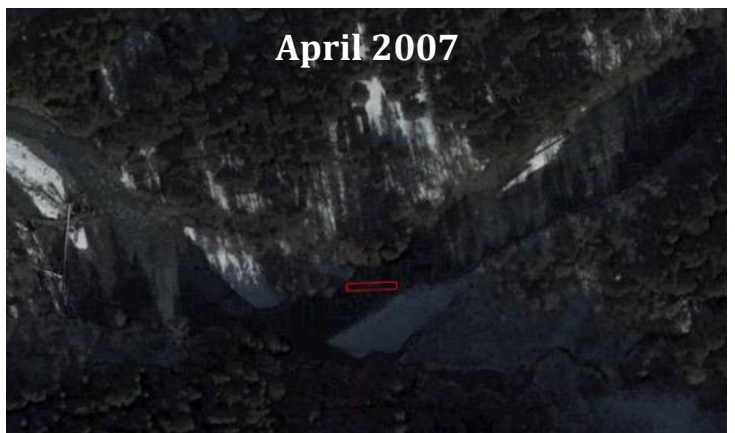
The big changes came in the winter of 2006-2007 when heavy flooding ravaged most of Western Washington. That was the winter when the Big Four footbridge was washed out and made the popular hike to the Ice Caves inaccessible for the summer of 2007. Notice in the 2007 image that the river, with the ground covered with snow, had drastically changed course and was flowing over the entire ruin. Notice that no longer was there much of a canopy of trees. When the water receded, the 2009, 2011 and 2013 images showed about the same location for the ruin,

which had finally started to poke out from under the rocks to resurface after being buried for years. The 2015 image shows the river and the ruins were barely visible over the next two years. There was another significant change in the river between the June 2015 image and the July 2017 image. The most recent image, July 2018, is similar to 2017, and shows the majority of the ruins sticking way out into the river and visible in the piles of river rock, but still mostly submerged in shallow water. A closer look shows more of the details of the ruins, almost unbelievable when considering the image was taken from space.

Measurements taken using Google Earth "Tools" indicated that the rectangular shape was over 70 feet long and between 11 and 12 feet wide. This seemed awfully large, yet very intriguing. A quick road trip to the site made for some interesting discoveries.

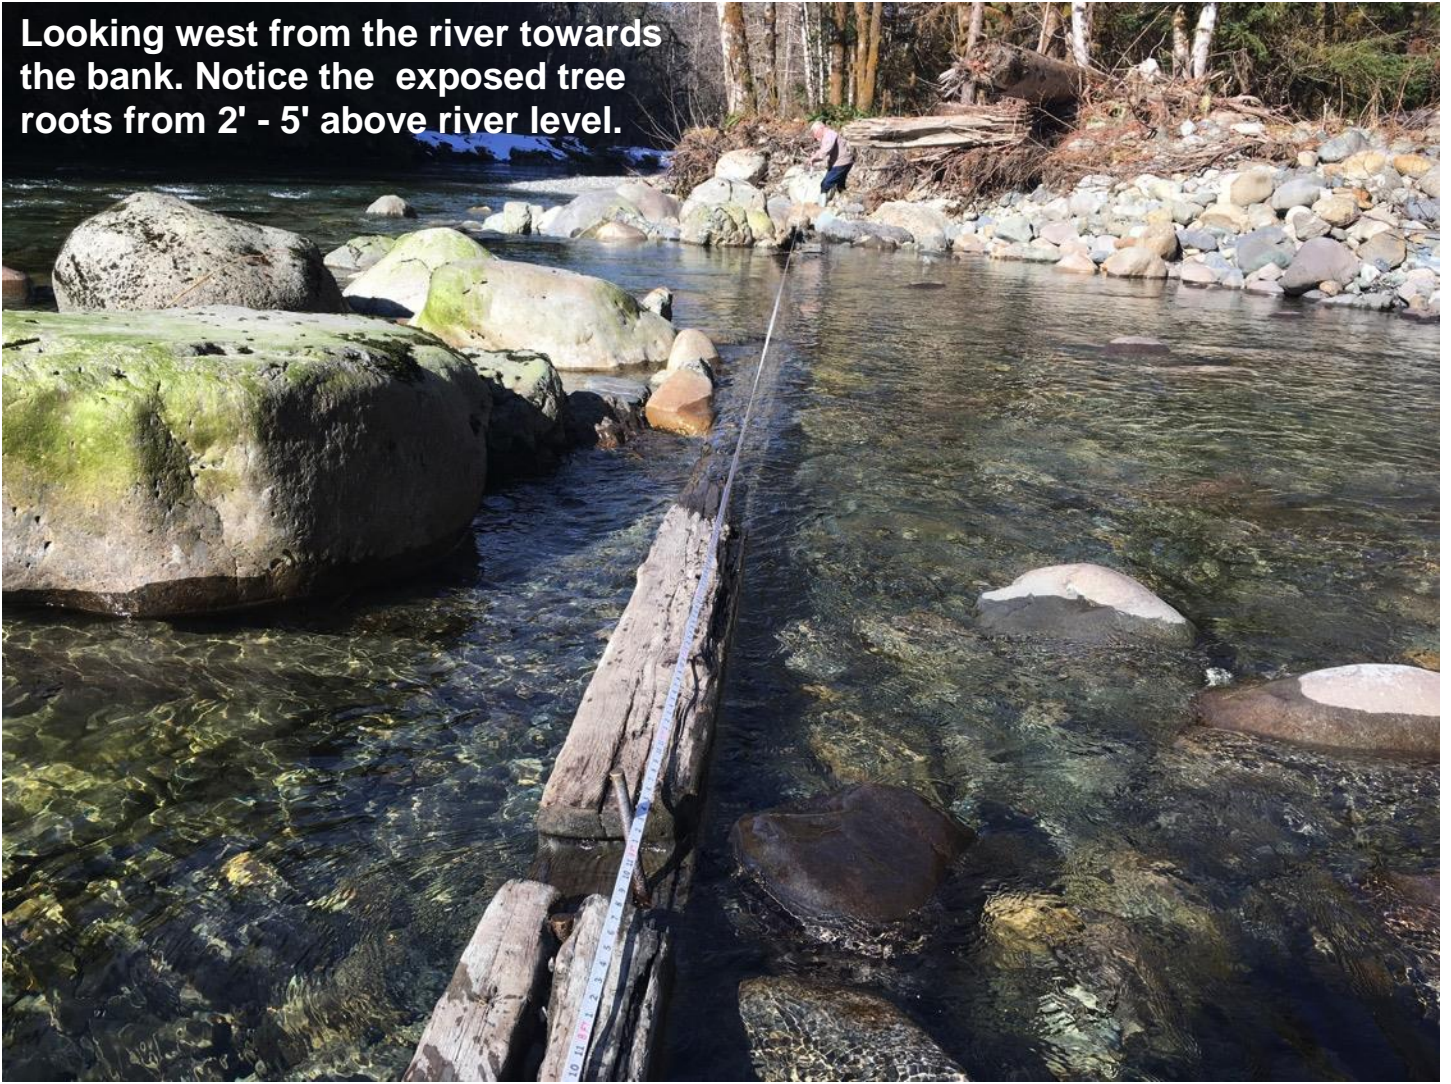
Looking west from the river towards the bank. Notice the exposed tree roots from 2' - 5' above river level.

The pictures on the next page show the ruin. The structure was measured to be about 90 feet long and 11' wide (on center), confirming the size found by using Google Earth. There were large timbers, railroad ties, spikes and metal rods that were very well preserved. Notches were noted in the longer "stringers". The entire structure seemed to be intact, but with a few timbers missing (or at least hidden from view by the piles of rocks). Huge 3' - 6' boulders that were smooth but not really round were resting on top of the wooden structure holding it down. Other large rocks were also on top. This obviously looked like a bridge of some sort, and based on it's width and beefy construction, it most likely was a railroad bridge. But from where?

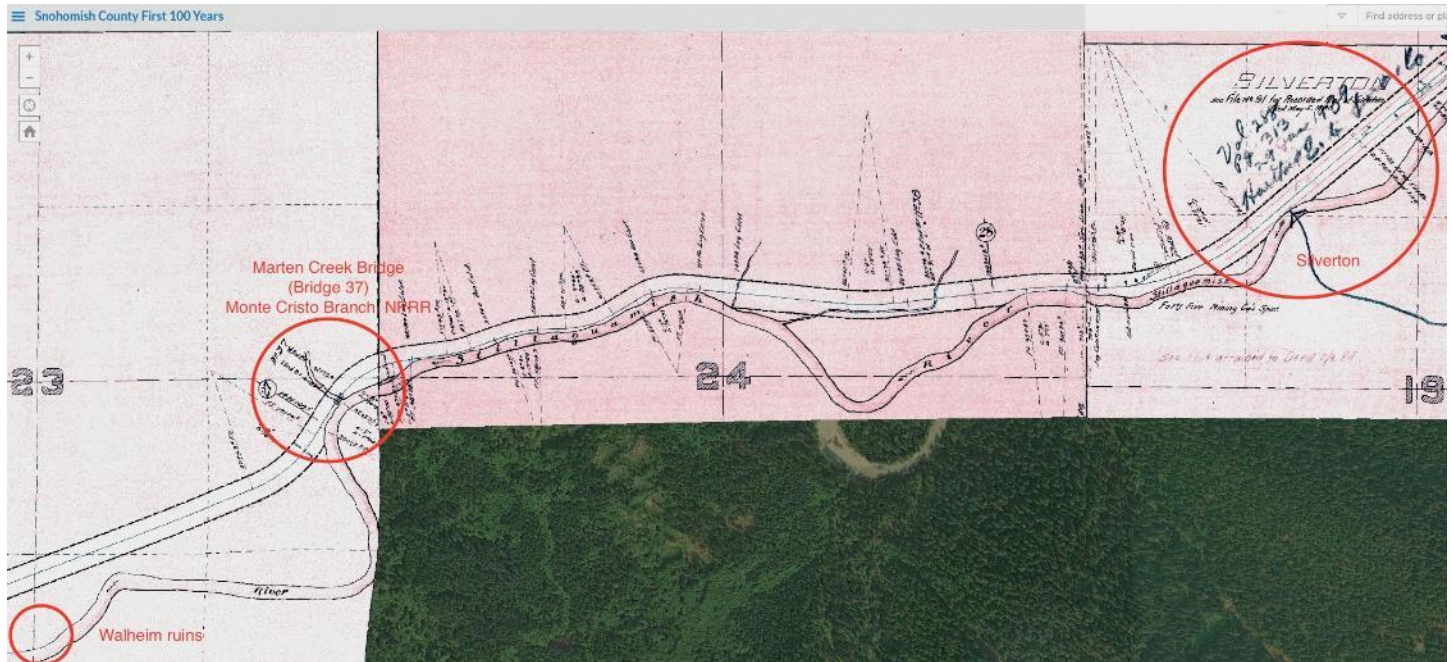
Observing the ruin on site, using actual measurements of the ruin, and referencing what we saw using the Granite Falls Museum's online historical maps, there are some interesting things to note. The "[homesteads and maps from the first 100 years of the county](#)" map shows several layers of historical and modern layers of Snohomish County. Selecting "Railroad NPRR" and searching for "Silverton WA" will get you the general area. By unselecting the NPRR layer, just the aerial photo can be seen. Reselecting the NPRR layer will show the railroad maps again. In the image below, the red circles and text have been added to the map to assist with orientation.

Because the data for the online map layers is very large, the online maps are a "lite" version of the full set of data found at the Granite Falls Museum (and at many other museums around the County). The online maps are an excellent launch for most any kind of historical research. When more detailed information is needed, the Museum's full set will show incredible details. In this case, take a look at the Marten Creek Bridge area when zoomed in. It is identified as (Bridge) "No. 37" and shown on the 1910 maps as "Martin Creek". The "E.End Br" numbers and the "W.End Br" numbers give the bridge length of 89.3' long! Now that's detail!

Bridge 37 at Marten Creek is the closest bridge upstream from the ruin site. Using the measuring tool, the distance from Bridge 37 to the ruin site is 3/4 mile ($\pm 100'$). The map shows the next bridge, Bridge 38, as only 15.1' long, but it is another 2 miles upstream from Bridge 37.
